Teploenergetika

RESTORING THE INITIAL HEAT-RESISTING PROPERTIES OF MATERIALS BY INTERMEDIATE HEAT TREATING

I.I. Trunin, Cand. Eng.

Results are presented of a study of
the degree of damage at various stages
of creep of specimens of a steel of
the austenitic class.

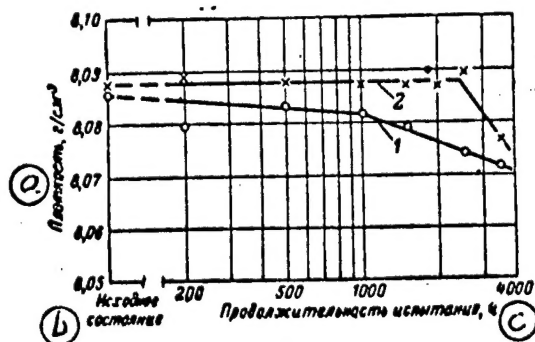
Fig 1 presents a plot of the variation of the density of the metal after creep (curve 1) and after the subsequent heat treatment (curve 2) for the specimens of the first group ($\sigma = 24 \text{ kg/mm}^2$).

Fig 1. Variation of the density of EI-257 steel during creep as a function of test duration
 $\Theta = 580^\circ\text{C}$, $\sigma = \text{kg/mm}^2$

1 - after creep test the specimen was work hardened by 10% elongation in the cold condition; 2 - after creep testing the sample was heat treated by heating to 800°C , soak for 5 hours, then work hardened in the cold condition by 10%
 a - density, g/cm^3 ; b - initial condition; c - test duration, hours

We note the following from Fig 1. The damage of the metal starts in the first stage of creep; after 200 and 500 hours of testing there is a reduction of the density. With

an increase of the testing time there is a noticeable acceleration of the damage process; after 1000 hours the rate of decrease of the density goes up. The major portion of the defects are subject to healing with heat treatment if the time to failure is not more than half used up, up to 2500 hours the density is practically completely restored; with longer test duration the magnitude of the density increases insignificantly, i.e. only the small failure centers are subject to healing. In the second group the stress rupture test was conducted at a higher stress ($\sigma = 26 \text{ kg/mm}^2$). Considering the static nature of the stress-rupture test and the associated scatter of the experimental data, we determined the mean time to failure from the results of numerous repeated tests.

Some additional information on the kinetics of the stress rupture is given by a comparison of the results of the study of the investigation of the samples of the first (Fig 1) and the third (Figs 3 and 4) groups. In the first group of the tests during the creep process there was no localization of the plastic deformation along the length of the working section noted in any of the samples (absence of a neck) and judging by the initial curves for the stress-rupture (Fig 5) the third stage of accelerated creep did not appear.

If we compare these data with the results of the healing (Fig 1) then we can note that a large number of the defects reach the critical dimension prior to the onset of the third stage of creep in the absence of the localization of the development of the plastic deformation. Actually, after 3500 hours of testing (Fig 1) there is observed a slight increase of the density after the heat treatment, i.e. a significant number of the defects exceeded the critical dimension.

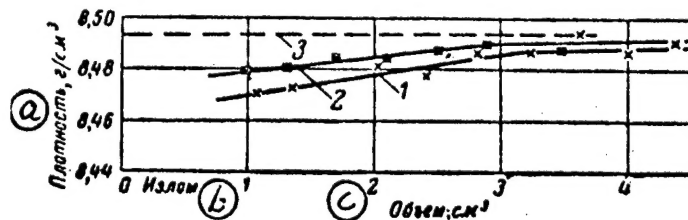
Fig 2. Variation of the density of the forging alloy TsZH-6 after stress rupture ($\theta = 7500$, $\sigma = 30 \text{ kg/mm}^2$, $\theta_k = 140 \text{ hours}$, $\epsilon_k = 9.0\%$, $\psi = 19.0\%$)

1 - after testing; 2 - after testing and heat treatment at 1200°C for 1.5 hours, annealed at 750°C for 20 hours; 3 - initial condition; a - density in g/cm^3 ; b - fracture; c - volume, cm^3

Figs 2 and 3 present plots of the variation of the density of two samples of the nickel alloy. Fig 4 shows the variation of the density in creep conditions of one of the samples of the grade EI-1T steel (Table 1). First of all we should note that in both cases plastic deformations of similar magnitude, both overall (ϵ_k) and local (ψ_k) preceded the fracture.

Analysis of the results of the study of the accumulation of defects in the zones adjacent to the fracture showed that during the first stage of creep the initiation and the growth of the defects takes place throughout the entire volume of the working portion of the samples. However in this stage the dimensions of the defects are small and they are subject to healing; the magnitude of the density reaches the initial level (Figs 2 and 4).

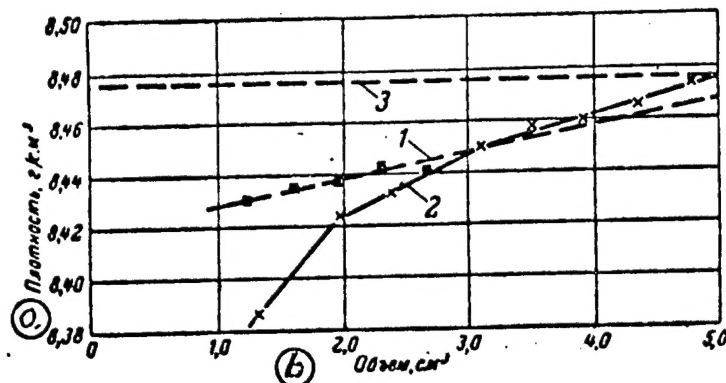
Fig 3. Variation of the density of the forged alloy TsZh-6 after stress rupture ($\theta = 7500$, $\sigma = 25 \text{ kg/mm}^2$, $\theta_k = 585 \text{ hours}$, $\epsilon_k = 9.2\%$, $\psi_k = 22.8\%$)

1 - after testing; 2 - after testing and heat treatment at 1200°C for 1.5 hours, anneal at 750°C for 20 hours; 3 - initial condition; a - density, g/cm^3 , b - volume, cm^3

Increase of the time up to the point of failure leads to a noticeable localization of the failure processes in the volume of the working portion of the samples. Right in the region of the fracture there is noted a significant acceleration of the decrease of the density (Figs 3 and 4). In this zone there probably occurs growth of the defects, most of which attain a critical dimension and their healing becomes impossible; after the restoring heat treatment the density of the metal is restored only by 50%. Judging from the plots of Figs 3 and 4 the healing is effective only prior to the localization of the failure process.

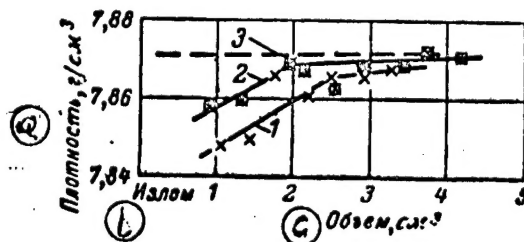
Fig 4. Variation of the density of the EI-1T alloy after stress rupture ($\theta = 6000$, $\sigma = 20 \text{ kg/mm}^2$, $\theta_k = 1846 \text{ hours}$)

1 - after testing; 2 - after testing and heat treatment at $1040-1100^\circ\text{C}$ for 30 min, anneal at 800°C for 10 hours; 3 - initial condition; a - density, g/cm^3 ; b - fracture; c - volume

Fig 6 is a plot of the tests of the two samples. The results of the measurement of the density of the metal of both samples practically coincided and this permitted drawing single curves for the variation of the density prior to and after heat treatment. Comparison of the graphs of Figs 4 and 6 shows that the variation of the density, and consequently the development of the fracture centers along the volume of the working portion during active deformation, does not differ in nature from the development of the defects in the samples during the creep testing. On the basis of these results we can draw the conclusion that defects formed by both the diffusion and the shear formation mechanisms are subject to healing.

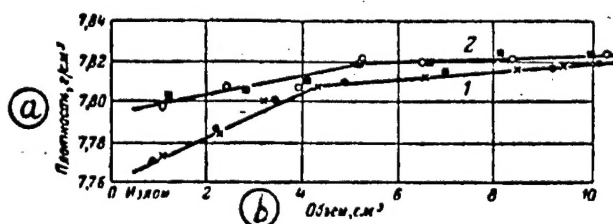
Fig 6. Variation of the density of steel 45 after short-term tension fracture
1 - after testing; 2 - after testing and heat treatment at 800°C for 5 hours
a - density, g/cm^3 ; b - volume, cm^3
